... Coastal Forum - 6 August 2024

# The Rowes Bay-Pallarenda Coastal System

... with integrated coastal leadership, management and regeneration, over 25 years

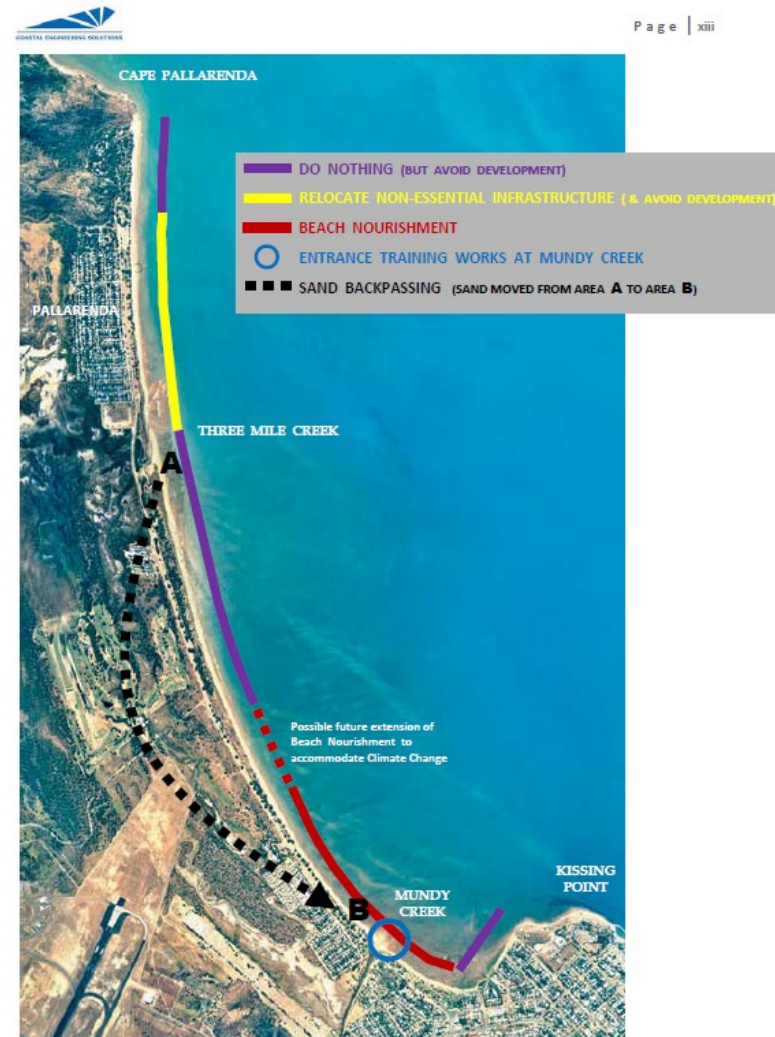
Recommended Shoreline Erosion Management Plan

The SEMP (2010) endorsed sand placement at Rowes Bay is intended to slowly erode and be distributed by natural processes northwards to replenish Pallarenda Beach with sand. Since nourishment has started, the sand has largely remained on the Rowes Bay Beach. The challenge is that the eroded scarp at top of beach is there, until the beach arc is rebalanced - with building a bigger beach (SEMP 2010)

Successful nourishment over several decades has resulted in an abundance of sand along the beaches towards 3 Mile Creek and at Pallarenda. Prior to 1998, Pallarenda Beach was sand starved, despite the offshore sand store at 3 Mile Ck.

Back passing of this excess sand from the 3 Mile Ck sand spit to Rowes Bay helps maintain the natural processes of sand movement within the bay and assists in preventing the 3 Mile Ck mouth from migrating northwards where it is generating some minor localised bank erosion due to tidal movements.

The modelled and estimated 900-950,000 m<sup>3</sup> off 3 Mile is calculated by SEMP coastal engineers to be a 500year accumulation of sand.

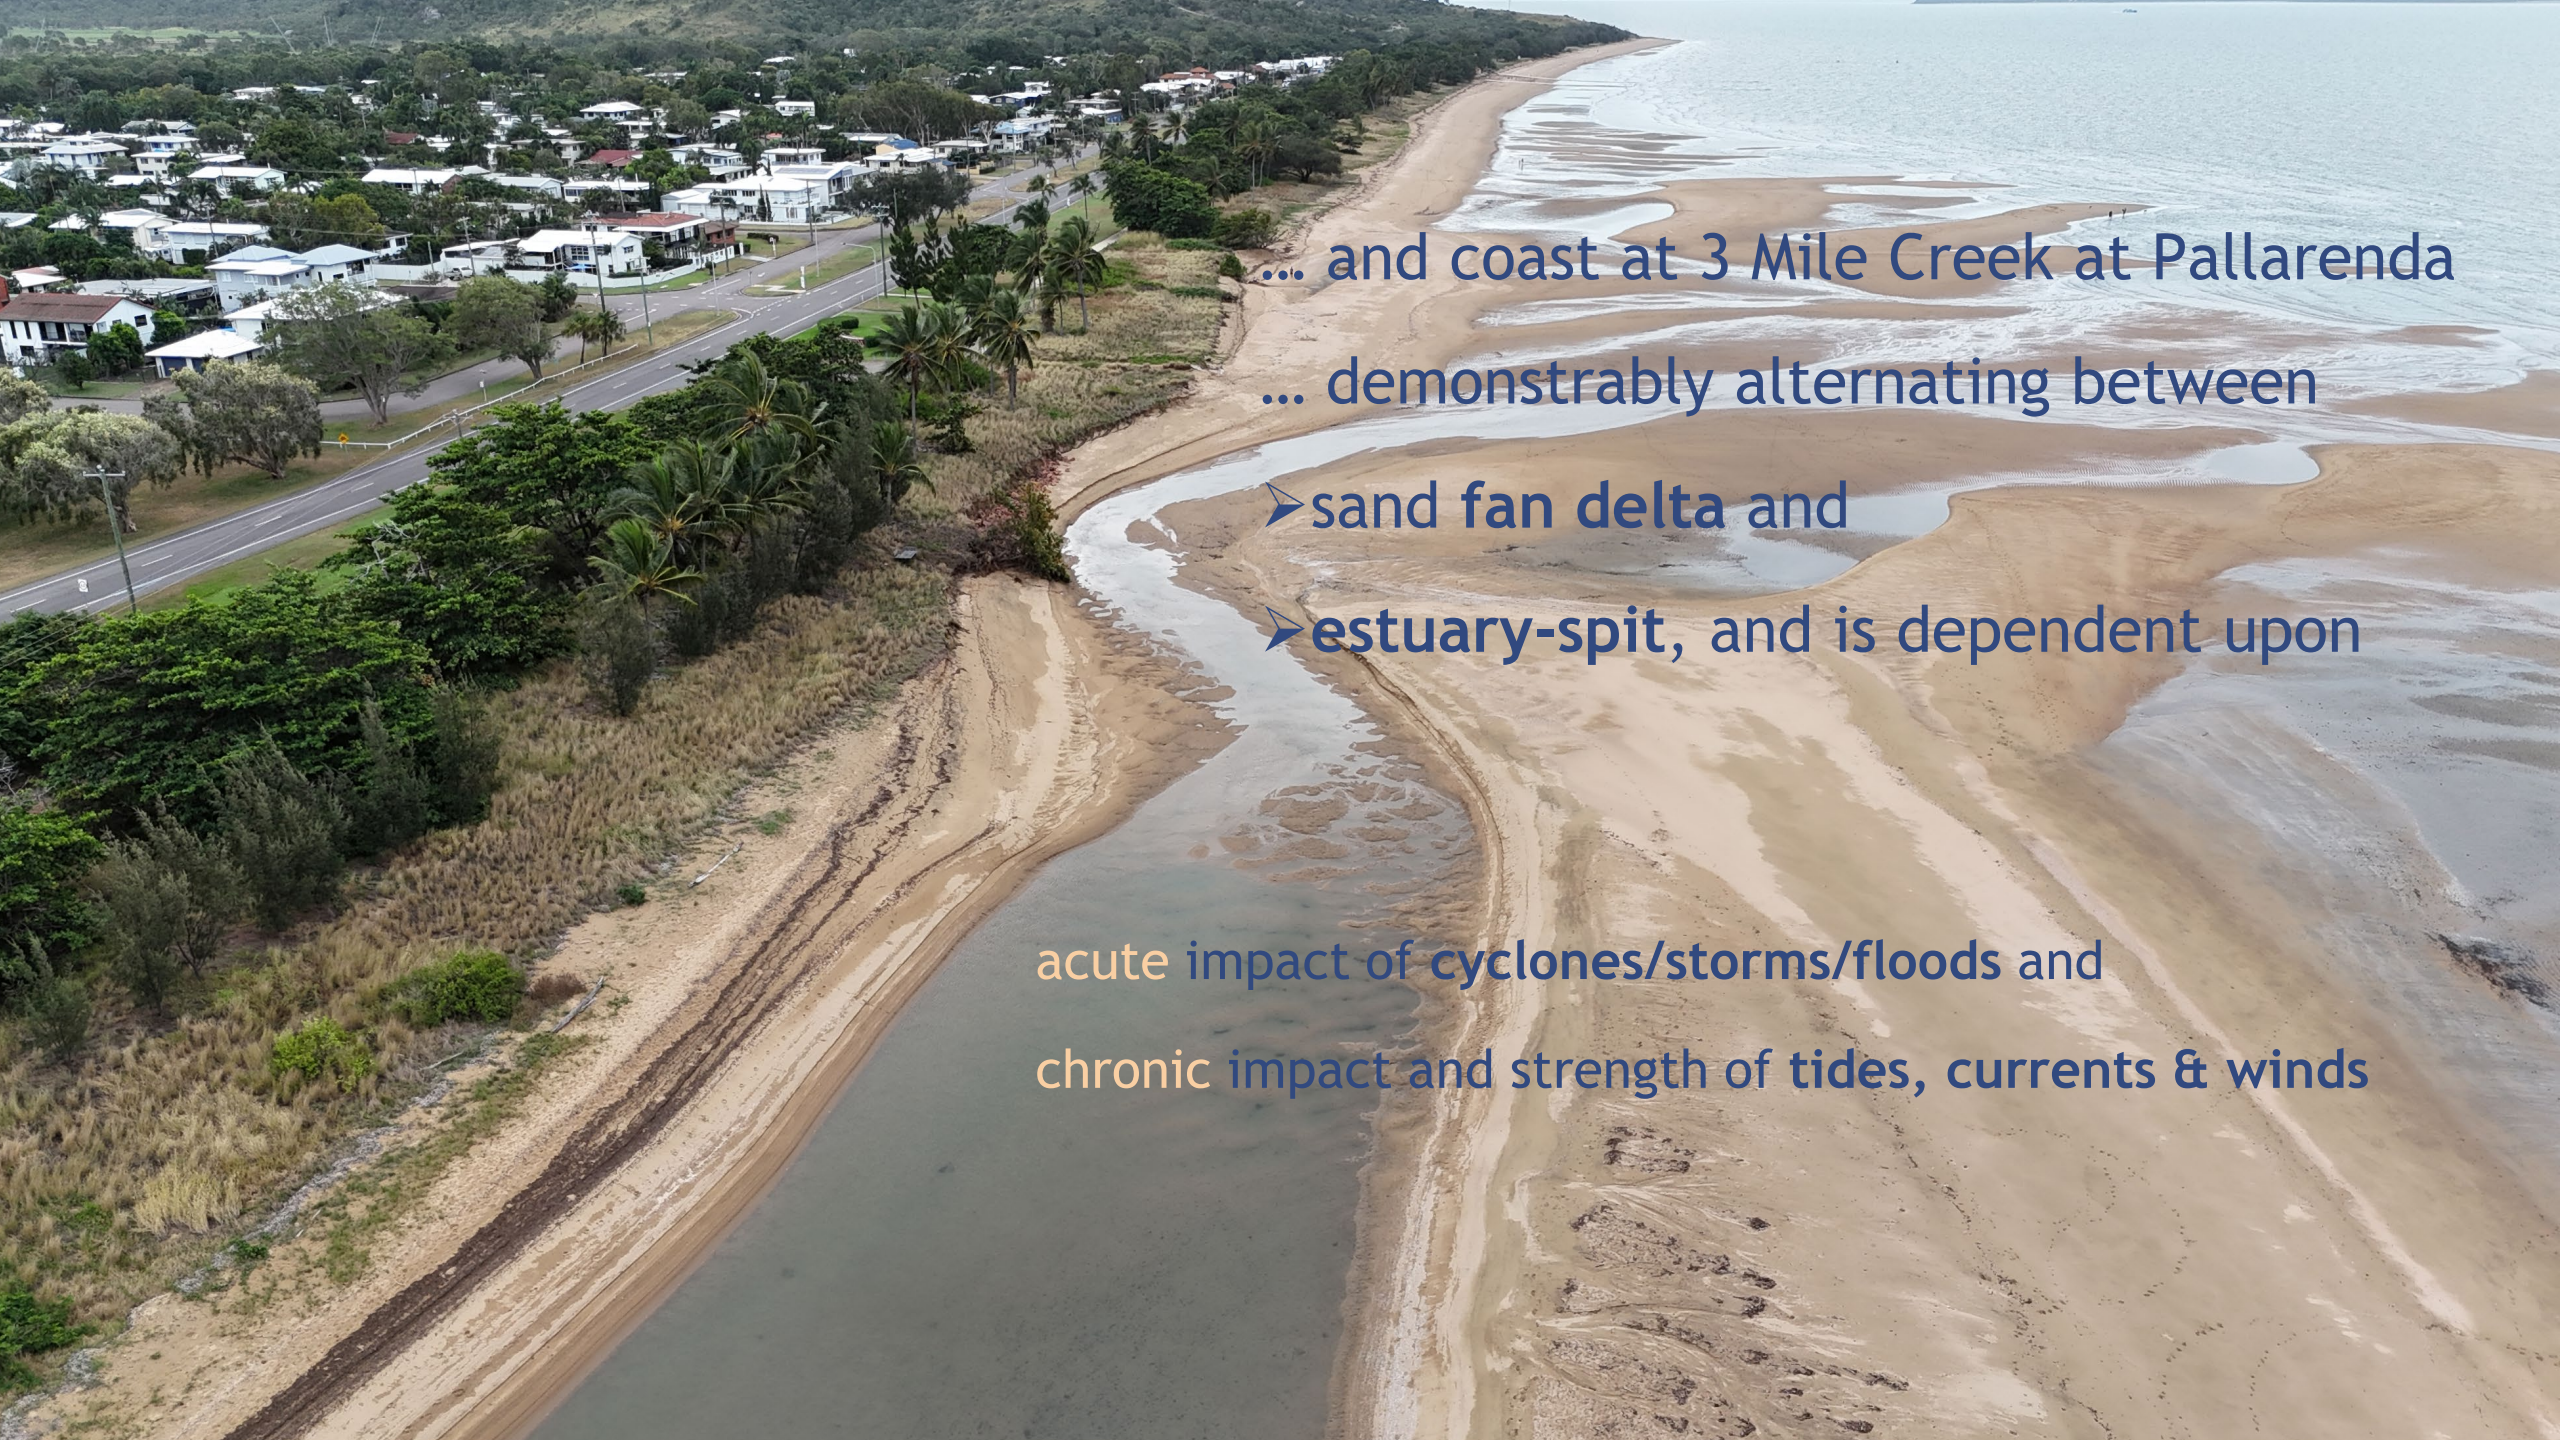
... and coast at 3 Mile Creek at Pallarenda

... demonstrably alternating between

➤ sand fan delta and

➤ estuary-spit, and is dependent upon

acute impact of cyclones/storms/floods and

chronic impact and strength of tides, currents & winds

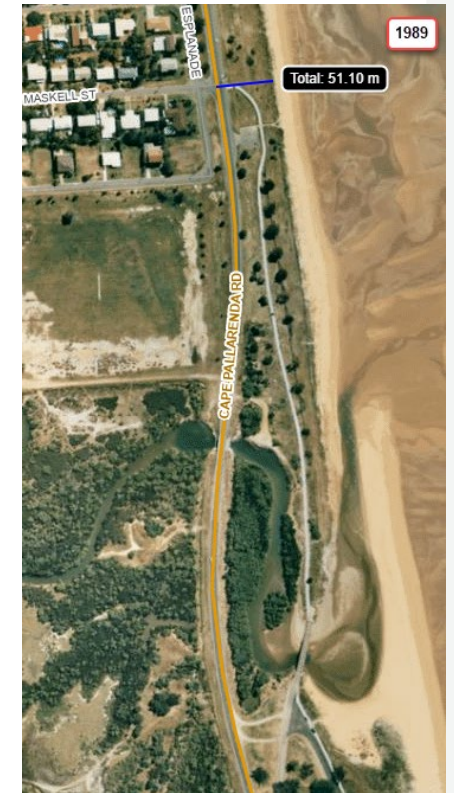
## ➤ “Forming of a sand spit”

- Sand spit comes and goes with time (cyclic) and independent of Council’s sand renourishment at Rowes Bay. The spit is formed via a natural process for tropical beaches including Pallarenda and influenced by local engineered infrastructure (roads, bridges and bunds).
- The spit forms from offshore coastal processes and storms and has occurred in the past many times and was further along the beach 10 years ago.
- There is evidence of previous spits, estuaries and deltas occurring when derived from air photos, going back to 1950’s. Air photos are intermittent and have gaps between their cycles of forming and eroding with floods (see photo opposite - 1989) and spits have formed at Pallarenda prior to 2010, when less sand was placed on Rowes Bay (RB) beach:
  - 80,000 m<sup>3</sup> from 1998 to 2010, out of a total 226,150 m<sup>3</sup> placed at RB in 2024

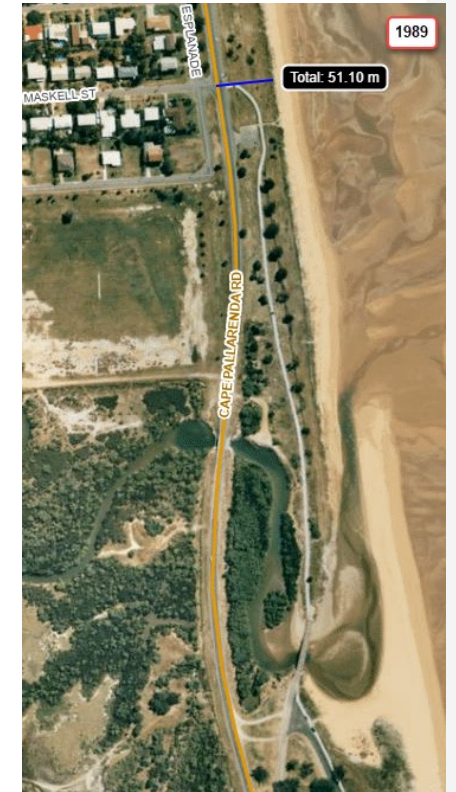
- **“Forming of a sand spit”**
  - Local bank erosion occurs where spit and estuary finishes. Where trees or human infrastructure (seating) find themselves in coastal ‘strand’ vine and foreshore vegetation then as elsewhere, they are at risk of this local erosion impact - being out on the beach slope and up against the post TC Althea rocks

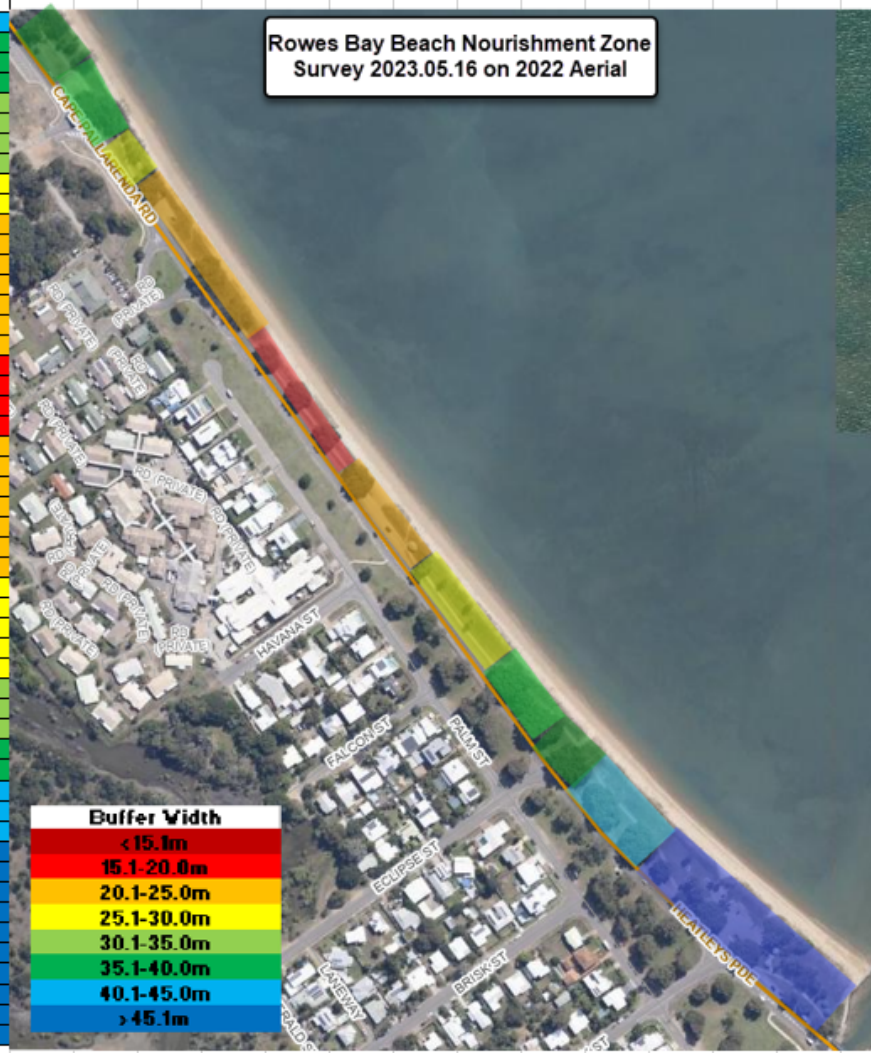
Rowes Bay Buffer Width (meters between Cape Pallarenda Rd edge and Top of Beach)

Medium term goal is to maintain buffer width greater than 20m at all times. Long Term goal is to establish a 30m buffer throughout, returning to pre Cyclone Althea, (1970) condition

Council's medium-term goal is to nourish Rowes Bay to maintain a buffer width of greater than 20m between the road and top of beach at all times and the long-term goal is to establish a 30m buffer throughout. The buffer at Pallarenda is twice this width

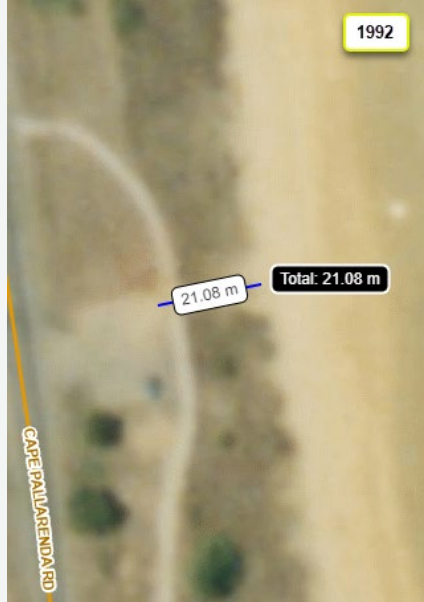
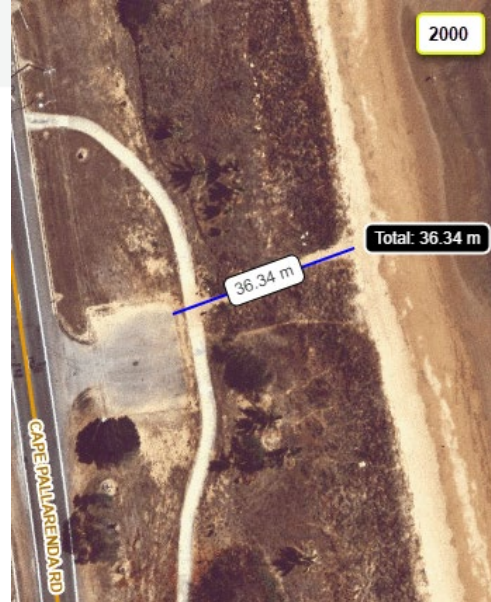
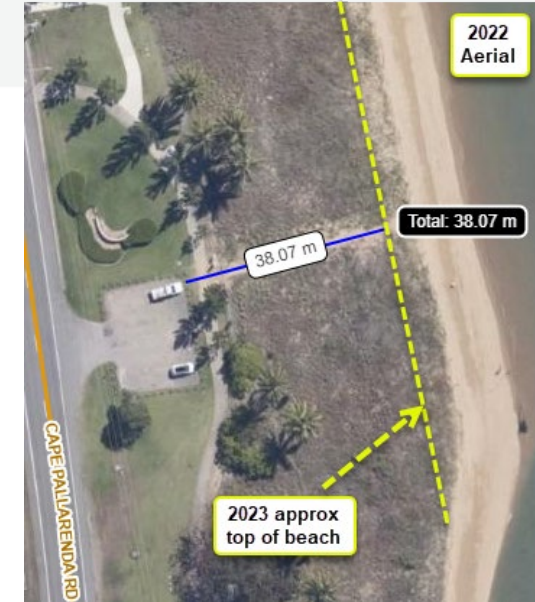
The buffer between the car park near Maskell Street & the top of the beach has increased by c.20-30 m from

- 21m wide in 1992 to
- 49m wide in 2013, and
- 38m wide in 2023, (red arrow).

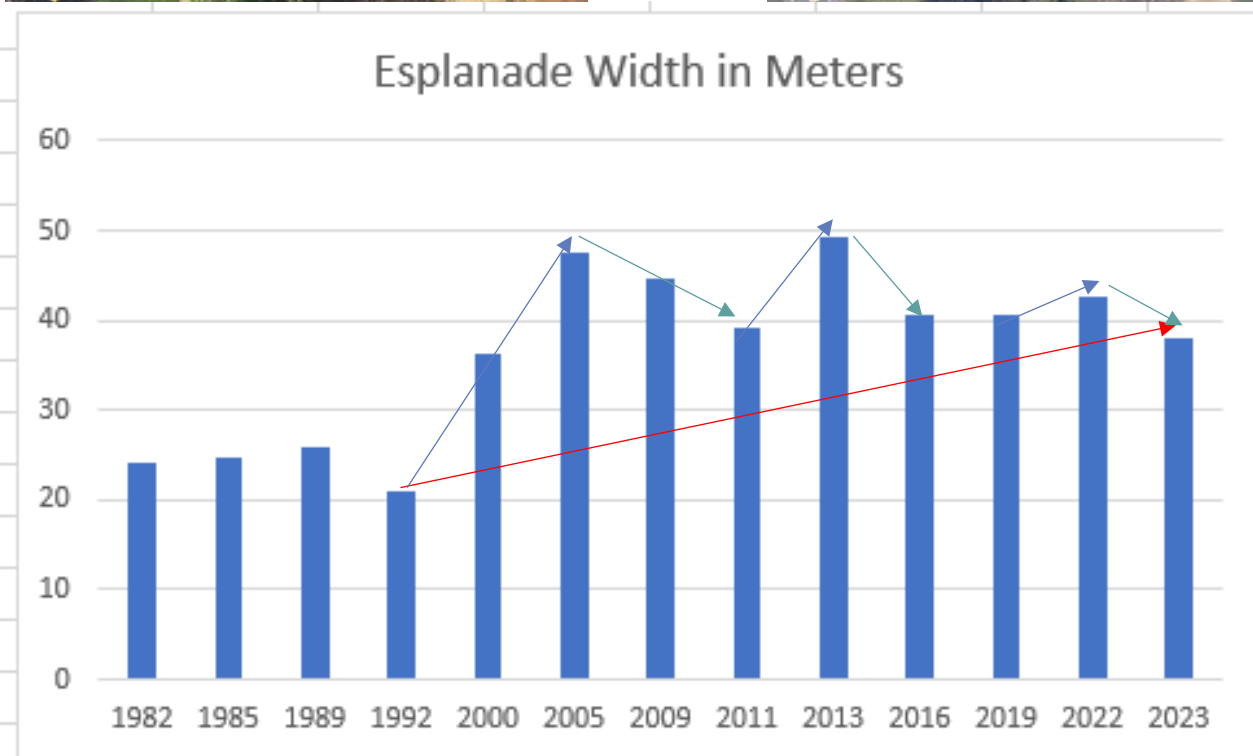
During this time the coast has experienced multiple periods of growth (blue arrows) and retreat (yellow arrows)

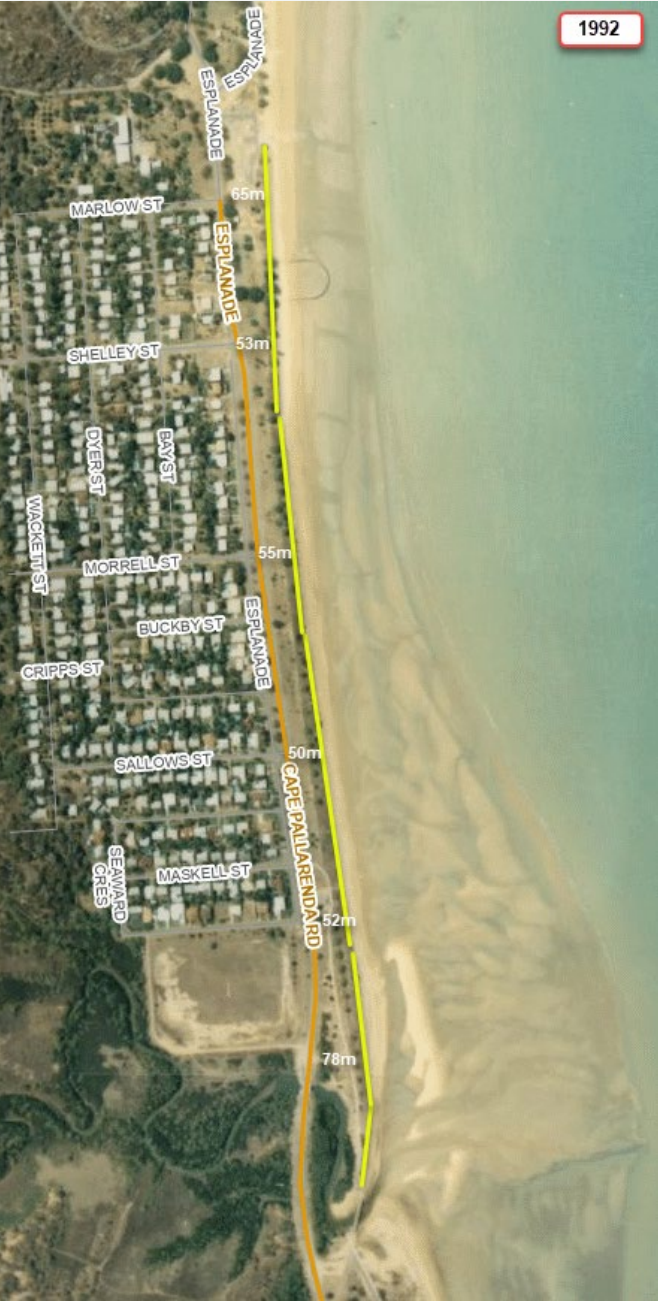
Pallarenda - Centre of Cape Pallarenda Rd to top of beach in 1992 average 58m

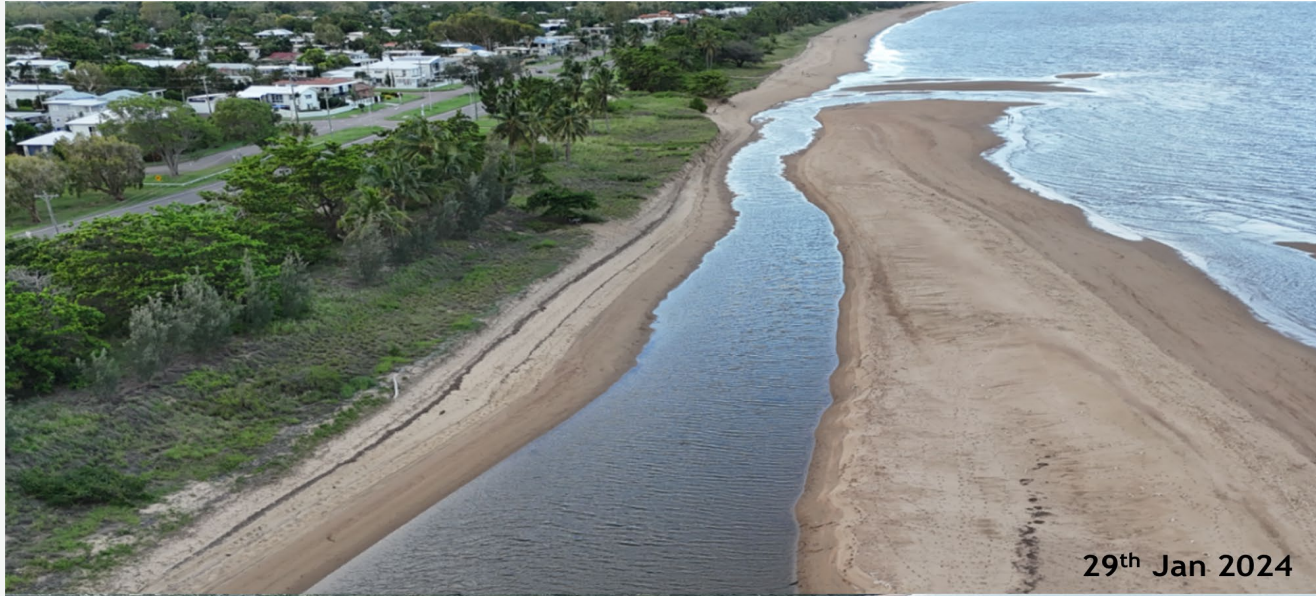
Top drone photo - 29 Jan 24

### 3 Mile Creek Mouth, Delta and Beach

Spit to Maskell Street

- By-passing work pre-post Cyclone Kirrily worked with storm and high tides (HAT), including sand harvesting from Spit (4000 m<sup>3</sup>) and bypassing back to Rowes Bay
  - See the photos overleaf
- Part of the spit was lowered to assist flood (storm) and/or tide impact (HAT)
  - Refer to oblique drone photos overleaf and associated digital terrain mapping (Jan 24 and May 24)

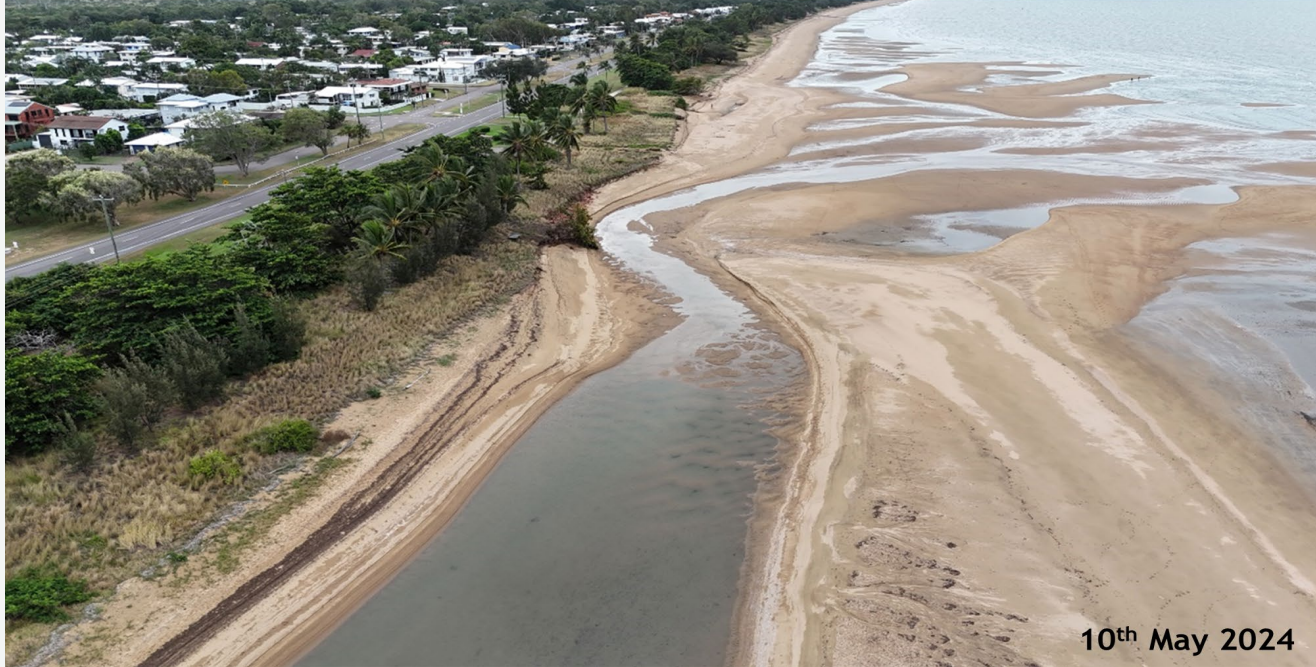
Bottom drone photo - 10 May 24

Redefined spit condition following TCC pre-TCC Kirrily back-passing work and mimicry of flooded waterway and delta process - opening has moved south.

Shows eroding bend of estuary mouth, and a fallen tree (10 years old) which was unfortunately growing in the 'strand vegetation' beach zone and always at risk from coastal erosion (Erosion Prone Area (EPA))

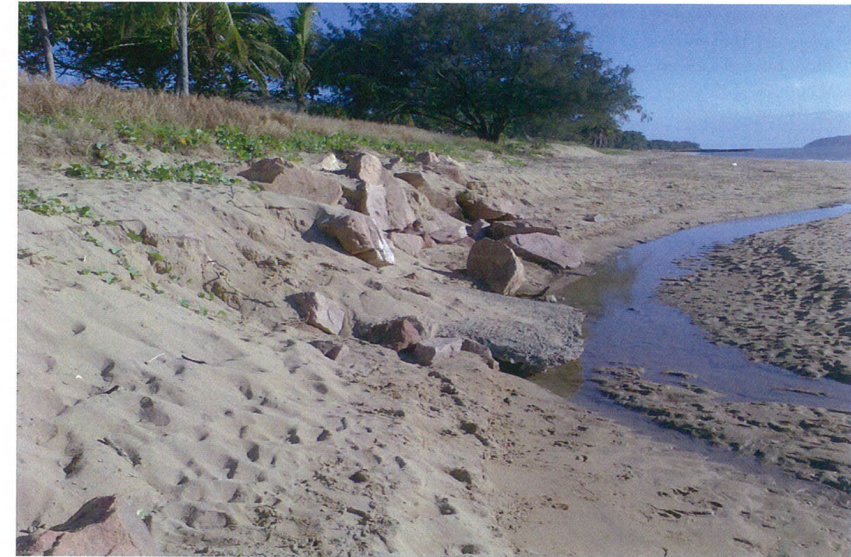
20 April 2011 Rapid sand recovery at beach access 16 due to Cyclone Yasi pushing the 3 Mile Ck sand bar into and joining the shoreline.

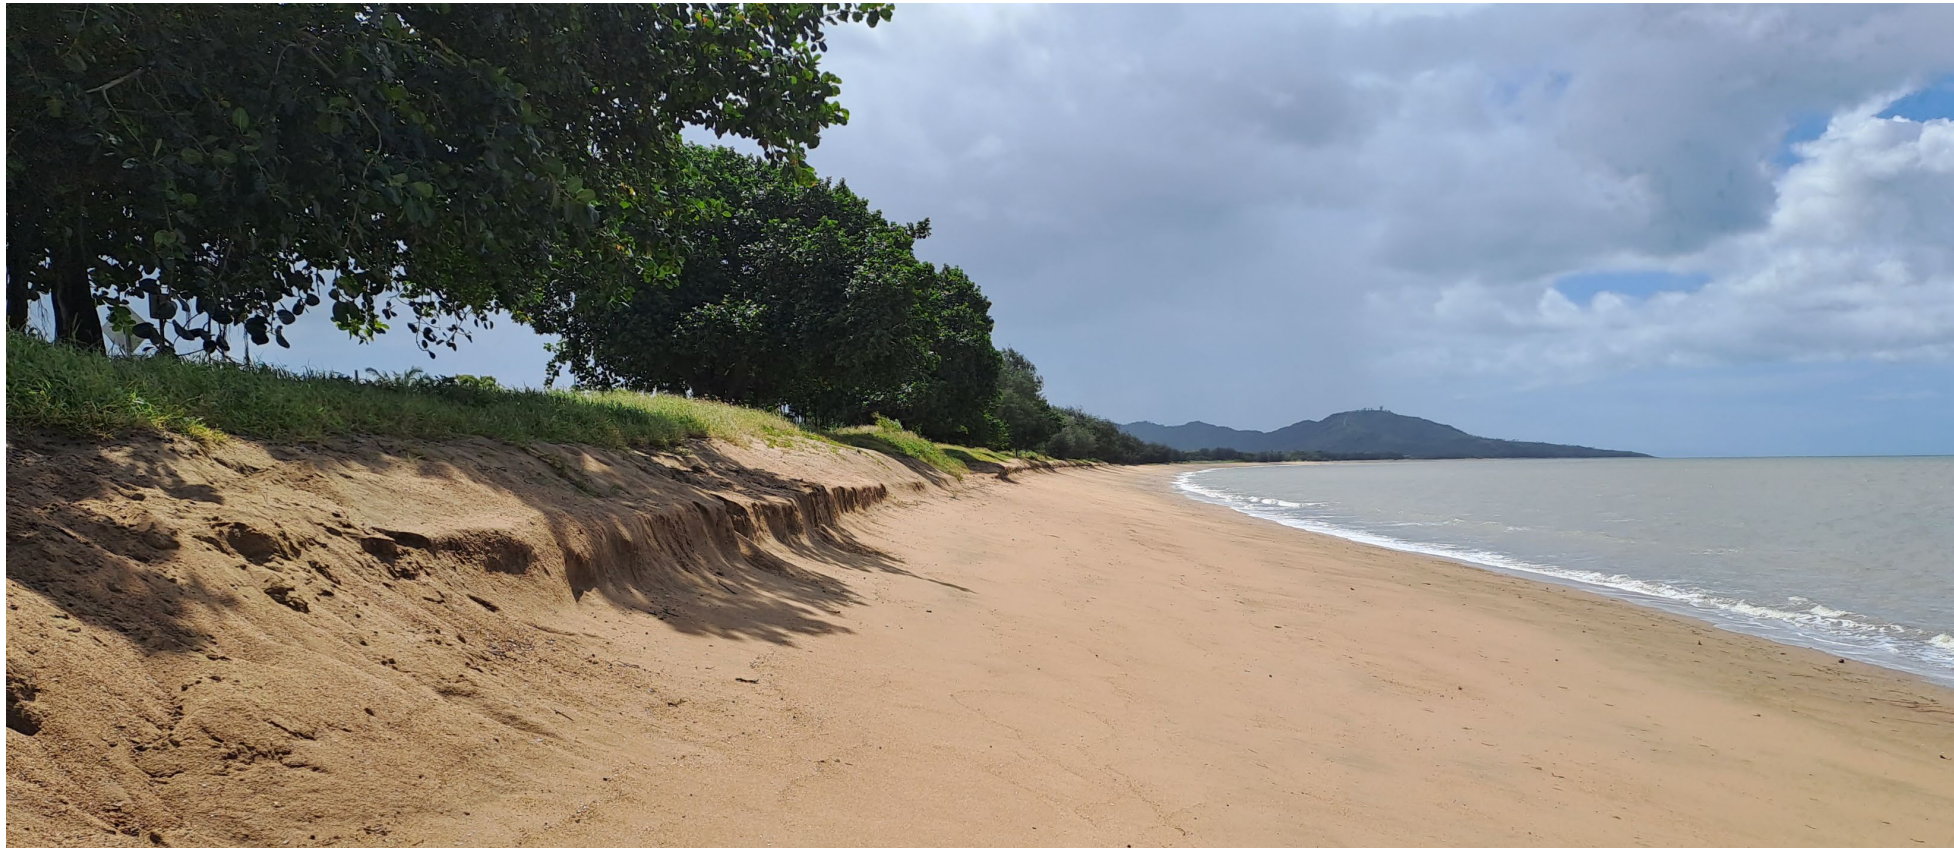
**Rowes Bay beach at medium tide, not low tide - a wide beach and variable scarp - plan to build out**
