# Option Analysis Report

## Coastal Inundation Risk Analysis - Closed Landfill Sites

Cairns Regional Council

4 December 2023

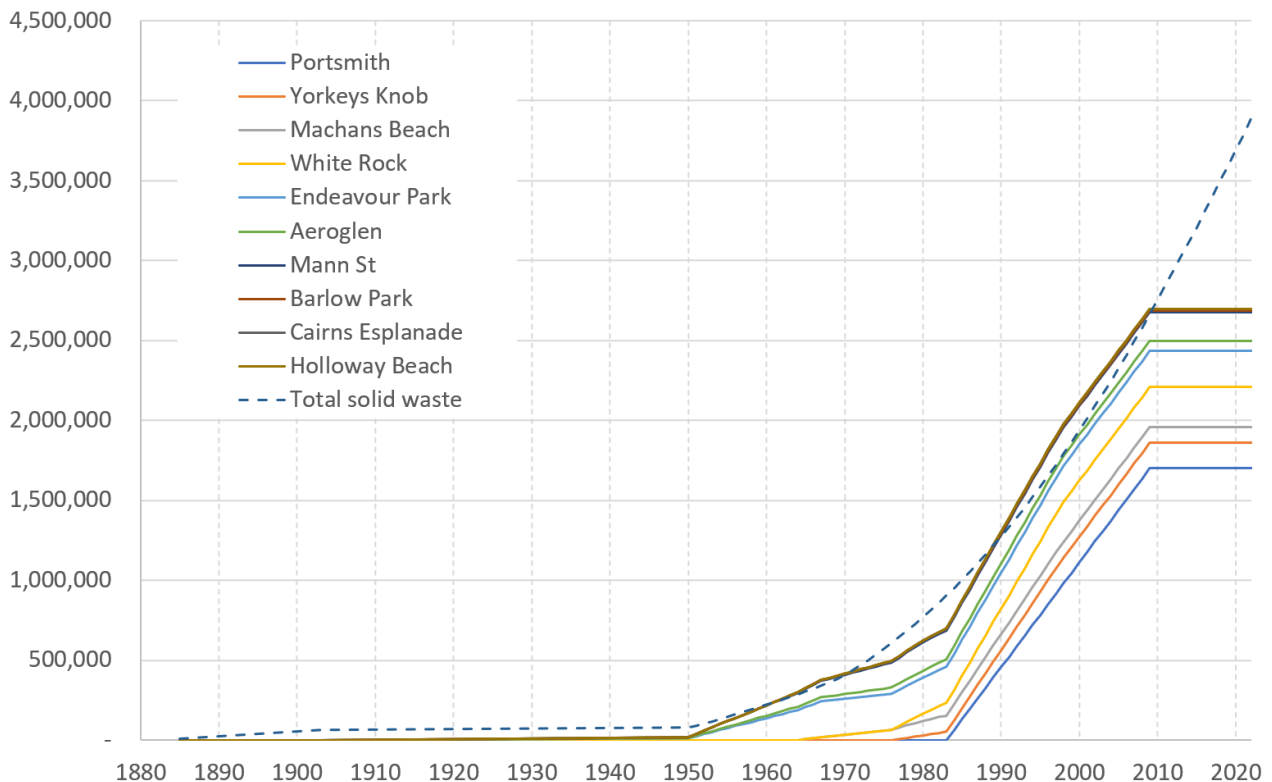
Figure 1-2 Coastal landfill capacity, tonnes

Portsmith alone constitutes about 60% of the total mass of coastal landfill. Figure 1-2 shows the cumulative coastal landfill mass across all sites and the estimated total solid waste generated based on ABS population data.

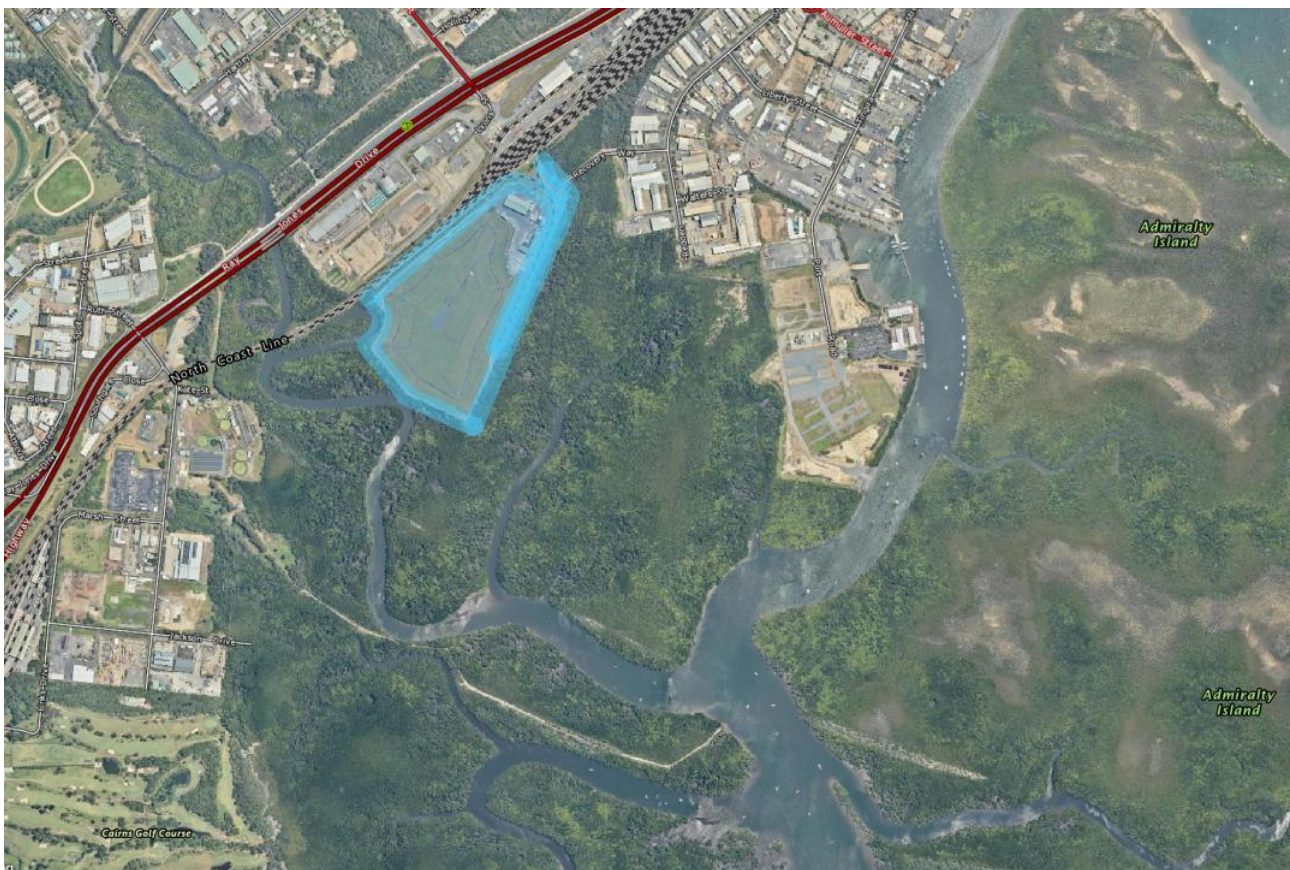
Figure 2-2 Portsmith Closed Landfill

Figure 2-2 shows site cadastral boundaries extracted from the Queensland Globe database.

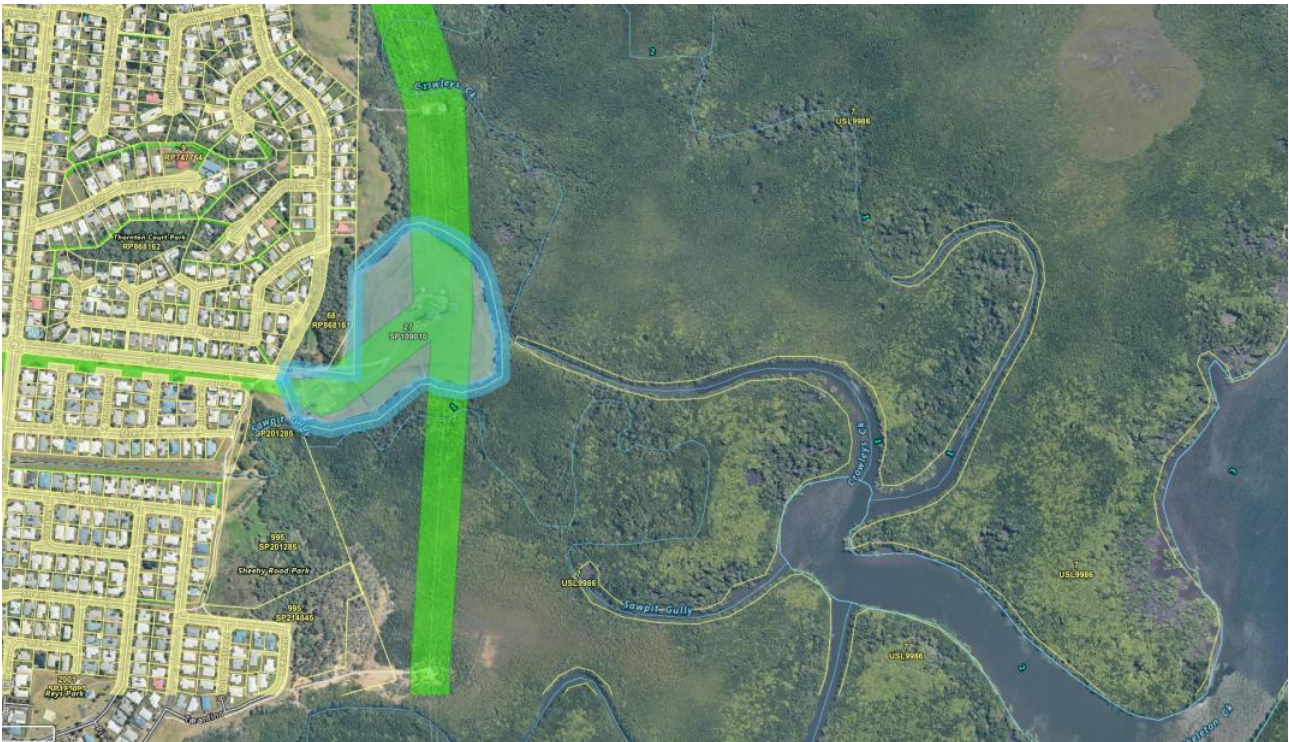
Figure 2-5 White Rock Closed Landfill

White Rock Landfill is located at the end of Sheehy Road, Lot 27 SP 109010 (Reserve). The site area is 5.87ha. The site is bordered by residential development to the west and a mangrove area to the north, east and south. Crowleys Creek flows along the eastern boundary and Sawpit Gully flows to the south of the site. Both drain into Skeleton Creek, Smith Creek and then Trinity Inlet. The site is approx. 10km upstream from the ocean. Figure 2-5 shows the extent of the site.

The site was cleared around 1977 and was active until 1998. Waste included mainly household waste, general waste and hardfill deposited on site. The waste area is enclosed in a perimeter bund to contain the waste and limit tidal ingress. The area within this perimeter bund would correspond to the landfill area and is approximately 5.3ha.

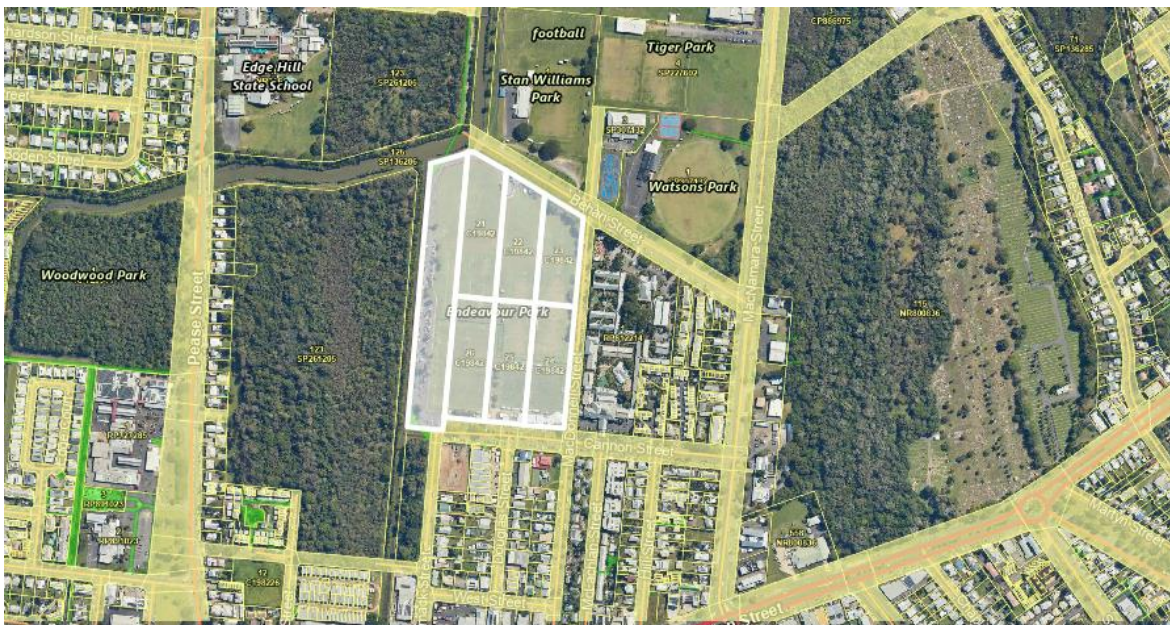
Figure 2-6 Endeavor Park Closed Landfill

The site is approx. 3.5km upstream from the ocean and is bordered by residential development to the east and south and a mangrove area to the west. An open drain runs along the northern boundary, which drains into Lily Creek. Lily Creek drains directly into the ocean south of the airport. Figure 2-6 shows the site cadastral boundaries extracted from the Queensland Globe database.

Council indicated that the landfill was active between 1950 and 1967. The site has been closed for approximately 56 years, with an estimated 2m to 3m landfill depth. The site was predominantly used to dispose of household waste, including plastic, cloth, glass and metal waste. The waste also contains asbestos-

The WSP Asbestos in Soils Management Plan (2022) details further that Council classified the blue area in Figure 2-6 as a “hazardous landfill” (car park area) while the remaining site (sports field) is a “Former Landfill”.

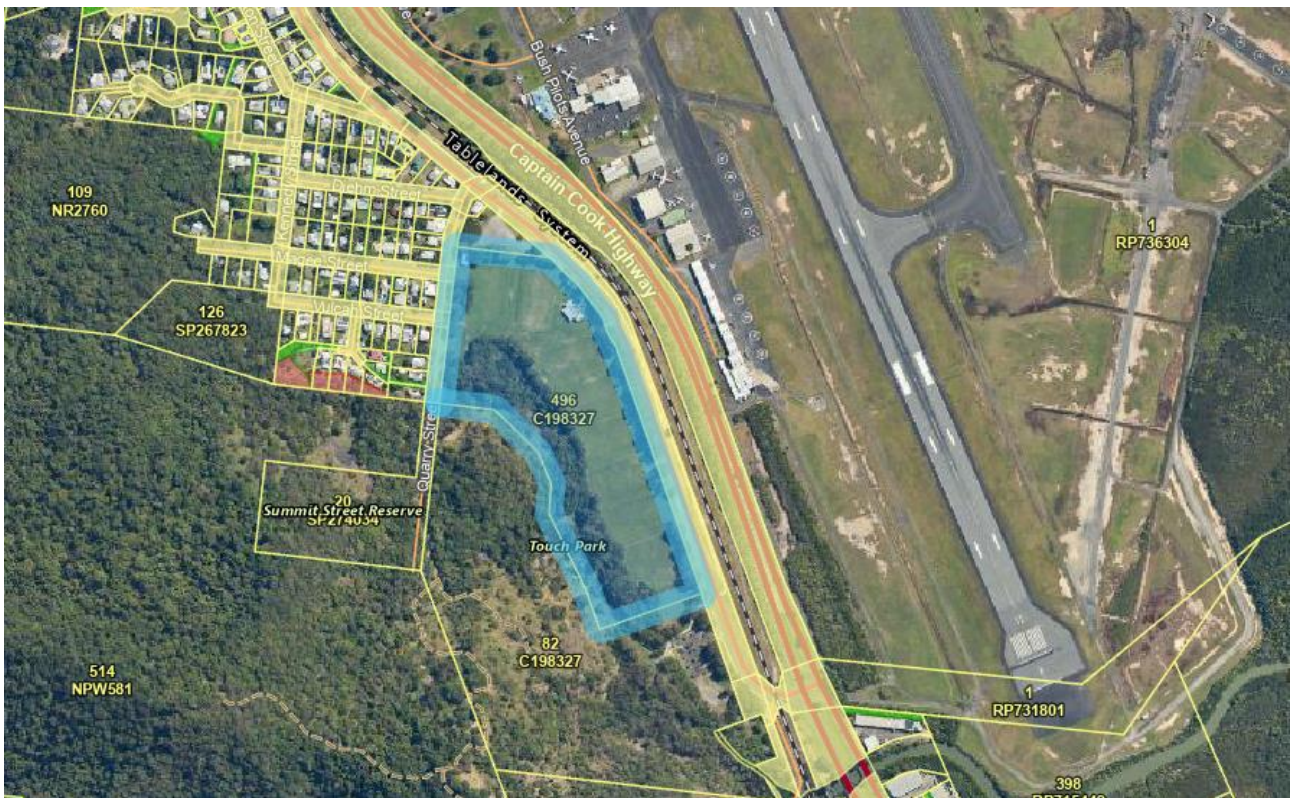
**Figure 2-7 Aeroglen Sporting Field Closed Landfill**

Figure 2-7 shows the site cadastral boundaries extracted from the Queensland Globe database.

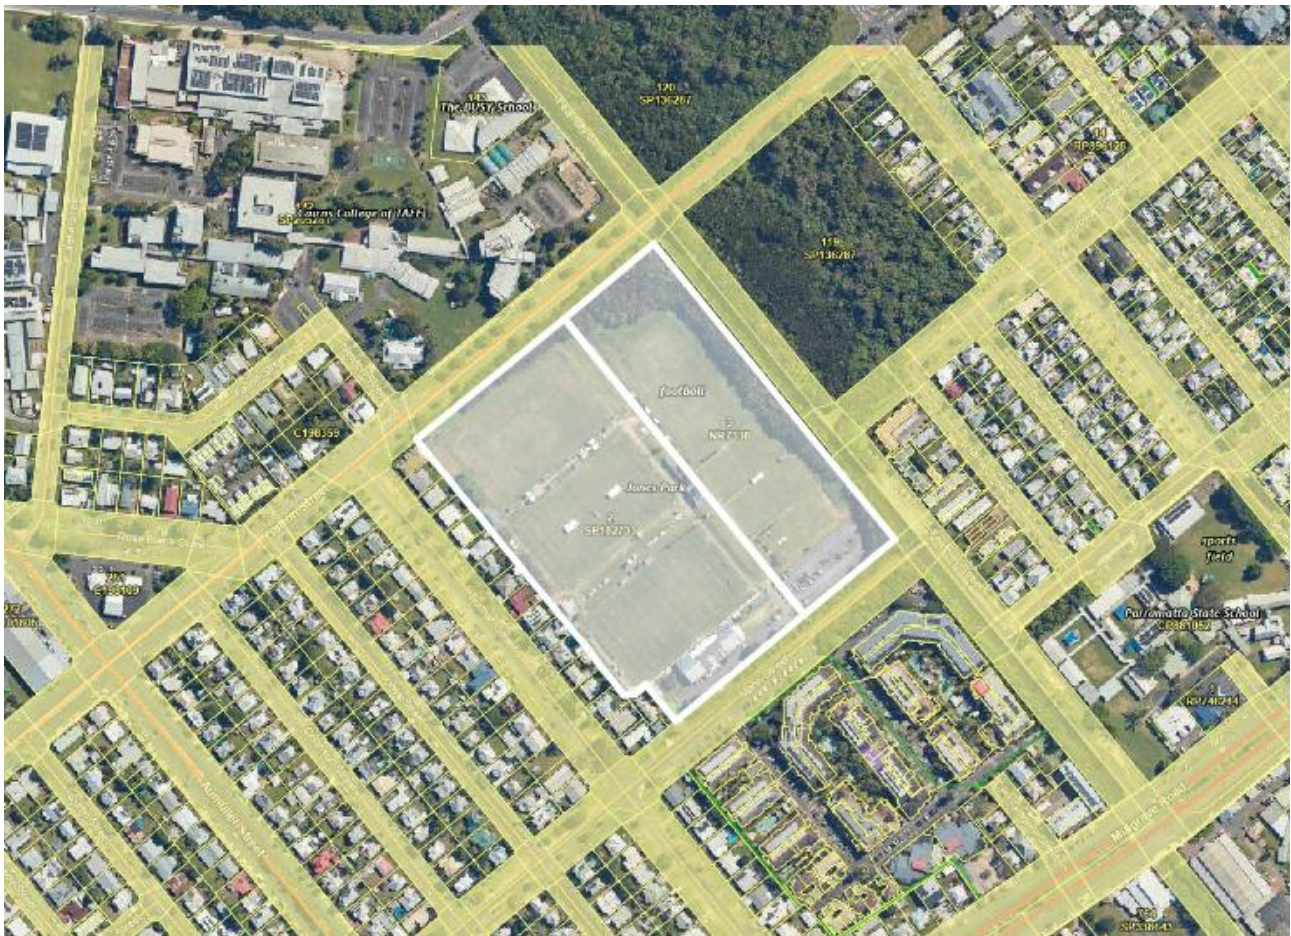
**Figure 2-8 Mann Street Sporting Field Closed Landfill**

The Mann Street Sporting Field closed landfill is located on Lot 2 SP182733 (Freehold) and Lot 3 NR7338 (Lands Lease). The site area, including the Jones Park sporting complex, is 8.914 hectares. Most of the site is covered by lawns, which is assumed to be the extent of the landfill site. The true extent of the landfill is unknown, although the State aerial pictures collection shows that the site was actively developed from the 1950s to the early 1980s, when the southern section of Lot 2 was developed into two sports fields. The field area drains towards Lot 3 and then into Smith Creek drain. Figure 2-8 shows the site cadastral boundaries extracted from the Queensland Globe database.

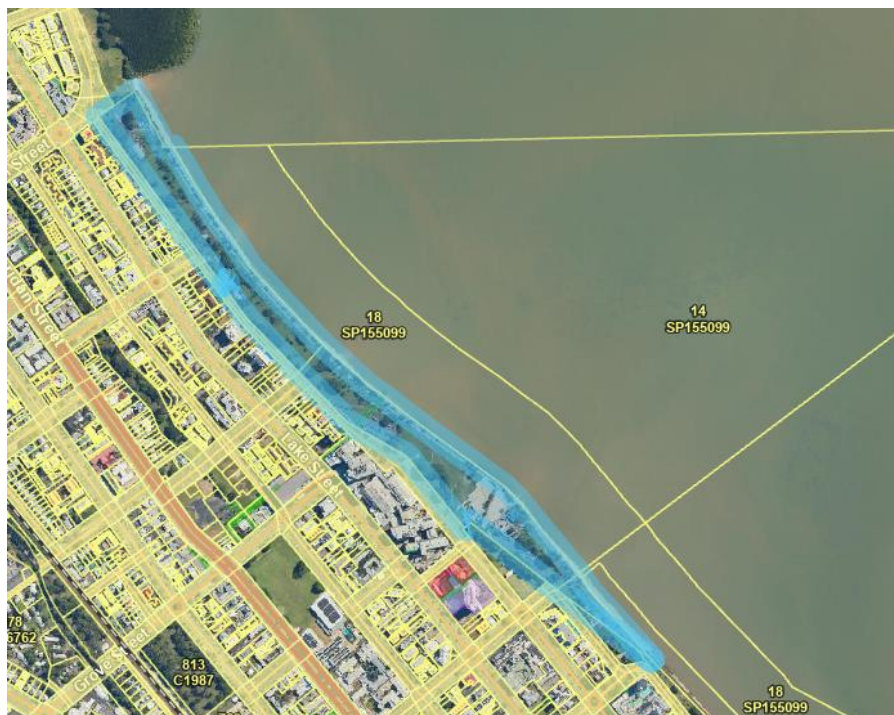
Figure 2-10 Cairns Esplanade Closed Landfill

The site is typically elevated and forms an informal coastal levee along the Cairns foreshore. The site forms a buffer zone between the built environment and the beach. The landfill area would be limited to the area outside the beach, approximately 11.0ha. A network of stormwater drains is located inland along the Cairns Esplanade roadway. A seawall of various forms and conditions has been built along the shoreline. Waste was identified on the Esplanade beach, such as bricks and asbestos fragments, during our site visit in December 2022.

Figure 2-10 shows the site cadastral boundaries extracted from the Queensland Globe database.
